RAY COUNTY DAM NO. A-1

MO 11084

**PHASE 1 INSPECTION REPORT
NATIONAL DAM SAFETY INSPECTION**

MAY 1979

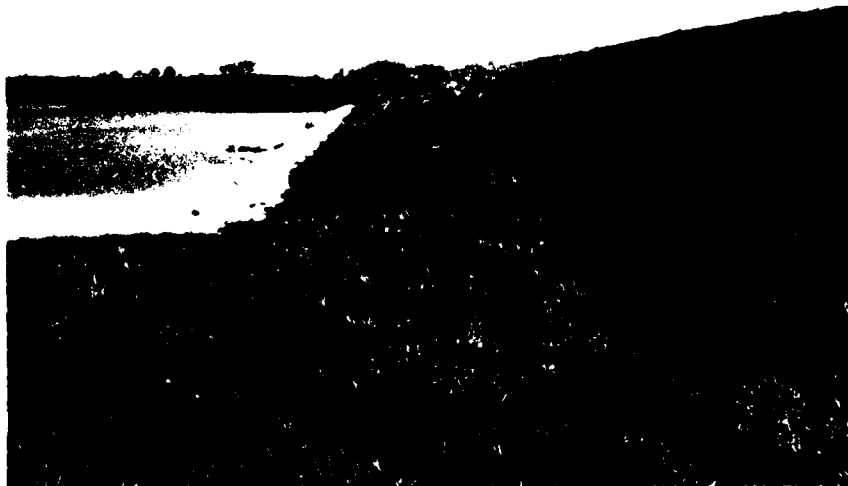
The riprap and grass slope protection on the upstream face are in good condition and appear adequate.

PHOTO 1: UPSTREAM FACE OF DAM

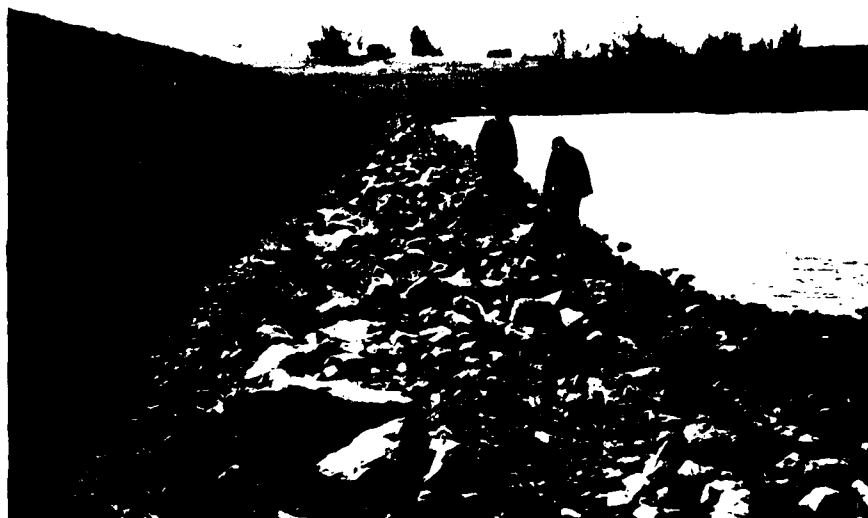
PHOTO 5: RIPRAP ON UPSTREAM FACE

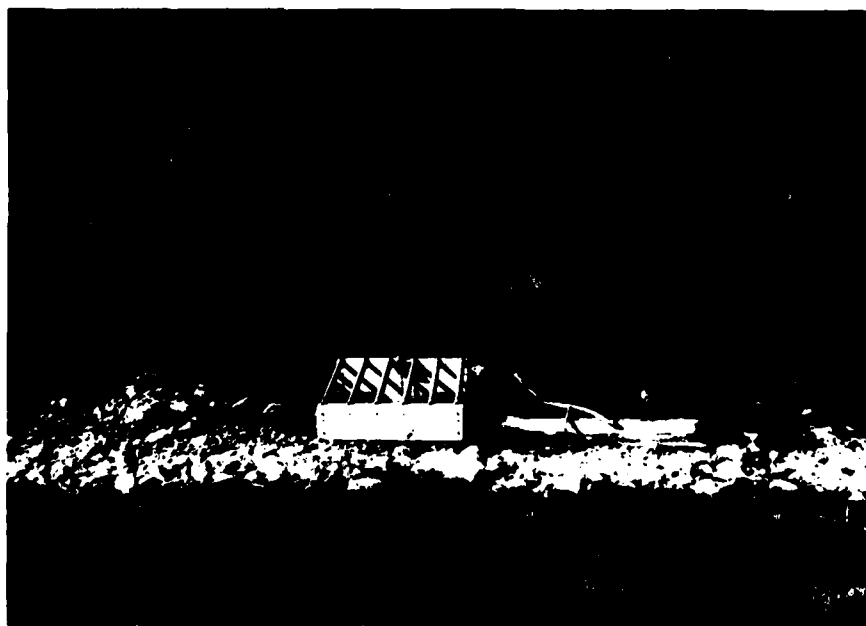
The principal spillway consisting of a drop inlet with trash rack appears to be in good condition.

The slide gate within the drop inlet was open approximately 4 inches at the time of inspection. The gate was in good operating condition at the time of inspection.

PHOTO 6: PRINCIPAL SPILLWAY

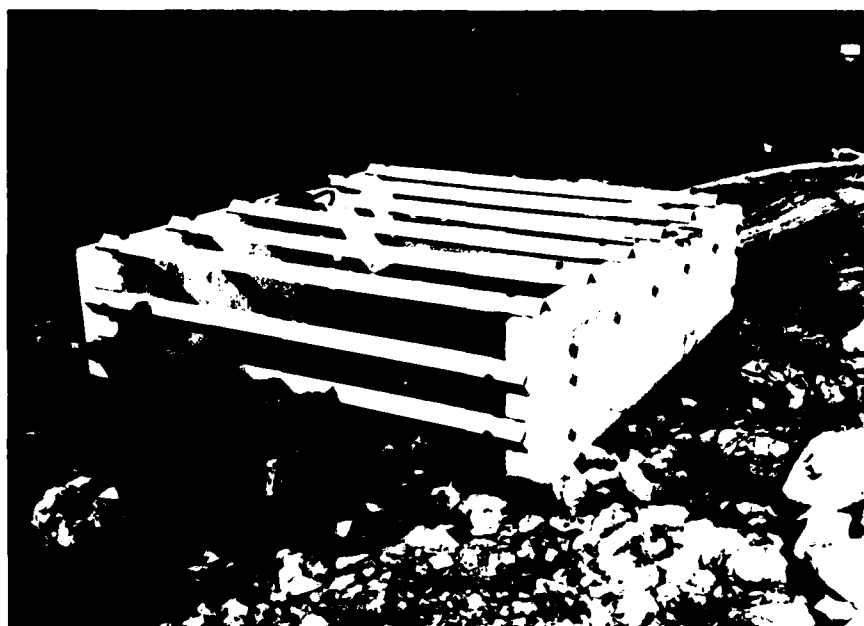
PHOTO 7: PRINCIPAL SPILLWAY

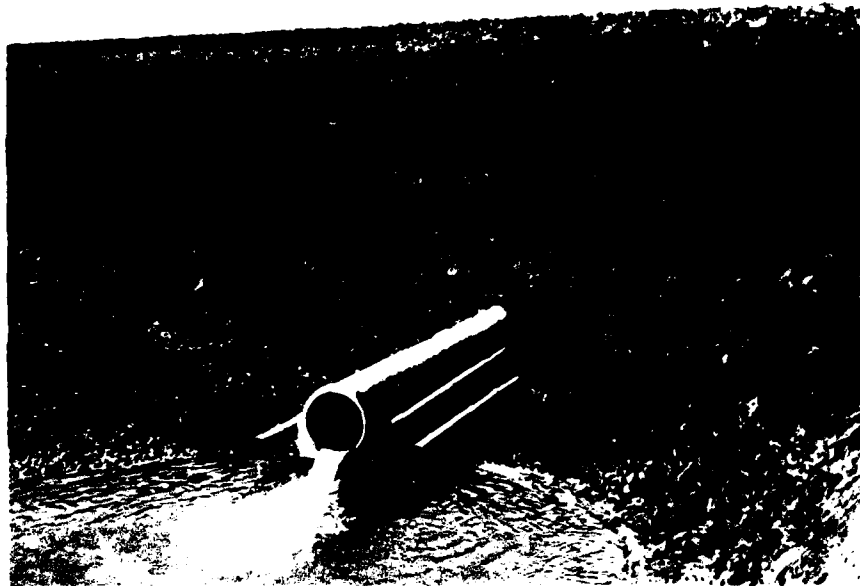
b. Dam. The inspection team observed that the dam is in generally good condition with minor seepage observed trickling from the twin, 6-inch asbestos-cement drain pipes. The flow of water was less than 1 gpm and was clear. The left pipe was noted to have slightly more drainage than the right one. Deficiencies noted during the inspection are as follows:

The greater flow observed coming from the left drainage outlet as compared with the right drainage outlet may be attributed to the fact that the left drain has a length of 221 feet, whereas the right drain has only 65 feet of perforated pipe as shown on the as-built drawings.

PHOTO 9: TOE DRAINS AND DISCHARGE CULVERT

(3) Controlled seepage should be monitored on a regular interval and records maintained documenting discharge and visible condition of the seepage discharged through the drain pipes. In the event quality or quantity conditions change, an engineer experienced in earth dam design should be consulted.
